Automation Service News

The Newsletter of Delta Automation Inc.

Grounding Schemes on different Modbus Plus Connector Types

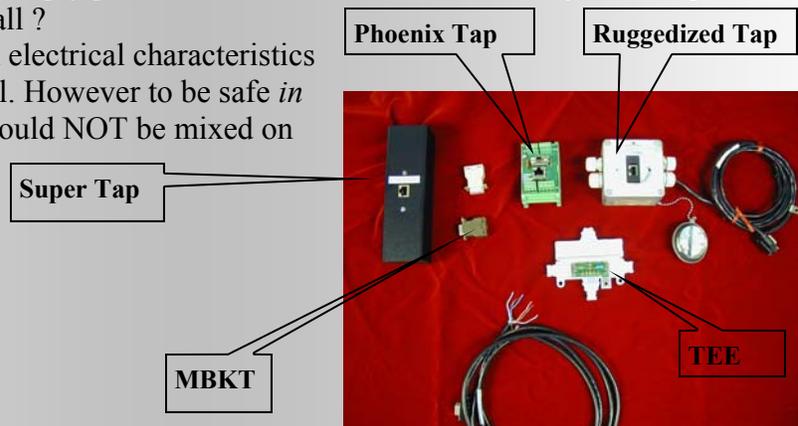
On the Modicon MBKT style connectors, the first generation of connectors placed in service, the grounding system is simply the cable shield and drain conductors daisy chained through all of the available connectors on the system. There is no consideration given to ground loops.

By mixing these two types of grounding schemes (daisy chaining and isolated) you *negate* the advantage of the isolation in a specific section of trunk cable. This arrangement could under some circumstances cause ground loops, ground currents and a disruption of communications. Although the manufacturer states that mixing the two types together has no ramifications; Delta Automation Engineers disagree. Simply put, if there is no difference, then why the design change in grounding schemes at all ?

Since no two systems are alike in electrical characteristics or noise levels, no one size fits all. However to be safe *in every case*, the different styles should NOT be mixed on the same electrical segment.

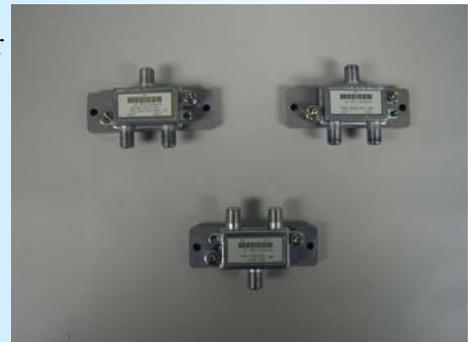
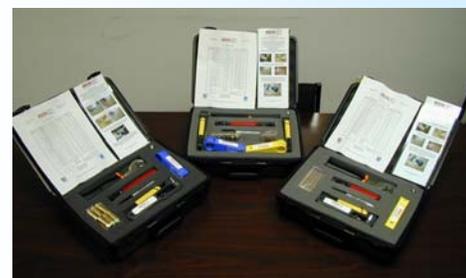
A typical Modicon remote I/O system consists of trunk cables, taps, splitter, drop cables, head-end device and remote devices. Some or all of these devices may date back to the early 1980's. Literally all of these items have evolved through numerous changes and revisions. The cable itself, has been re-designated to utilize only quad shielded product. The taps and splitters have had several changes to increase their efficiency. Of course the devices themselves have gone through radical changes from the 200 series through 800 to the Quantum line.

When performing an upgrade or PIP (product improvement program) usually the hardware is replaced. The application program is converted and or modified to function on the newer platform. However, the remote I/O system is, for the most part, overlooked by the individual quoting the project. There are many reasons to include these systems in with the project. Most obvious is revenue generation. Aside from that are the very real technical pitfalls that lie in wait for the end user and ultimately the personnel whom have to make it work. Delta Automation Engineers have been called in on emergency basis, after the fact, to get newly updated systems up and running dozens of times. In all cases, the problems could and should have been addressed during the upgrade itself. Typically in these emergency situations, there is not enough available downtime to properly rectify the situation. The system is patched until sufficient downtime is available and at that time all of the proper changes are made. In some cases, all of the remote I/O systems components must be replaced. Old single shielded cable must be replaced with Quad shielded. Along with the cable, the connectors are replaced. The old taps usually must be upgraded. In some instances, conduit routing is moved to better the physical layout. The electrical characteristics of the devices and the taps are quite different from the very old through to the very new. For example, the voltage level from the old J200, used on the 584 systems, is about half of what the level is on a modern Quantum system. On the surface, this appears to have little or no impact. However, on transmission lines, such as the remote I/O system, twice the voltage level means that any discontinuity along the line will cause twice the reflection of energy back to the source. This may prevent the system from functioning at all. At the very least it will cause errors. Discontinuities are caused by any deviation from the normal impedance level of 75 Ohms. The older taps (round in shape) have a typical impedance of 200 Ohms! The Modicon revision "A" taps are nearly as high. A Quantum system will *not*

function with these taps if placed close enough to the source of energy (head-end).
