Automation Service News

The Newsletter of Delta Automation Inc.

Grounding Schemes on different Modbus Plus Connector Types

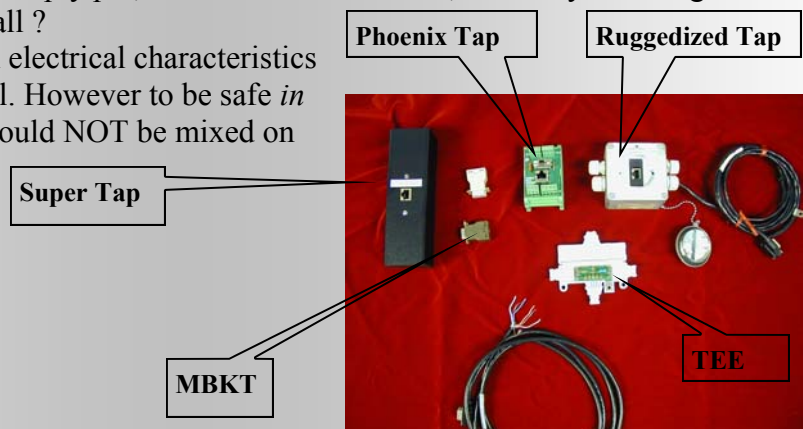
By mixing these two types of grounding schemes (daisy chaining and isolated) you *negate* the advantage of the isolation in a specific section of trunk cable. This arrangement could under some circumstances cause ground loops, ground currents and a disruption of communications. Although the manufacturer states that mixing the two types together has no ramifications; Delta Automation Engineers disagree. Simply put, if there is no difference, then why the design change in grounding schemes at all ?

Since no two systems are alike in electrical characteristics or noise levels, no one size fits all. However to be safe *in every case*, the different styles should NOT be mixed on the same electrical segment.

On the Modicon MBKT style connectors, the first generation of connectors placed in service, the grounding system is simply the cable shield and drain conductors daisy chained through all of the available connectors on the system. There is no consideration given to ground loops.

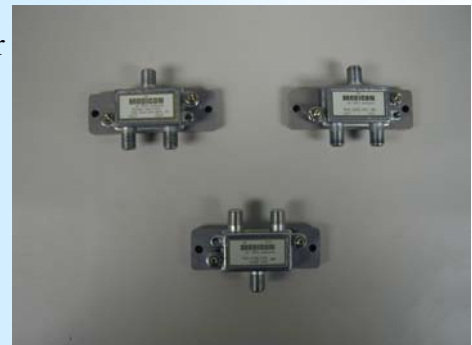
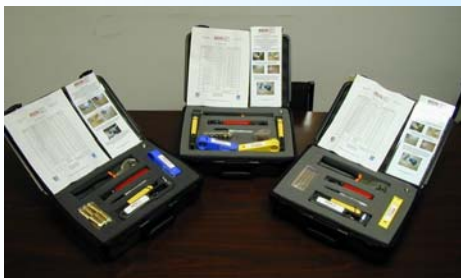
A typical Modicon remote I/O system consists of trunk cables, taps, splitter, drop cables, head-end device and remote devices. Some or all of these devices may date back to the early 1980's. Literally all of these items have evolved through numerous changes and revisions. The cable itself, has been re-designated to utilize only quad shielded product. The taps and splitters have had several changes to increase their efficiency. Of course the devices themselves have gone through radical changes from the 200 series through 800 to the Quantum line.

When performing an upgrade or PIP (product improvement program) usually the hardware is replaced. The application program is converted and or modified to function on the newer platform. However, the remote I/O system is, for the most part, overlooked by the individual quoting the project. There are many reasons to include these systems in with the project. Most obvious is revenue generation. Aside from that are the very real technical pitfalls that lie in wait for the end user and ultimately the personnel whom have to make it work. Delta Automation Engineers have been called in on emergency basis, after the fact, to get newly updated systems up and running dozens of times. In all cases, the problems could and should have been addressed during the upgrade itself. Typically in these emergency situations, there is not enough available downtime to properly rectify the situation. The system is patched until sufficient downtime is available and at that time all of the proper changes are made. In some cases, all of the remote I/O systems components must be replaced. Old single shielded cable must be replaced with Quad shielded. Along with the cable, the connectors are replaced. The old taps usually must be upgraded. In some instances, conduit routing is moved to better the physical layout. The electrical characteristics of the devices and the taps are quite different from the very old through to the very new. For example, the voltage level from the old J200, used on the 584 systems, is about half of what the level is on a modern Quantum system. On the surface, this appears to have little or no impact. However, on transmission lines, such as the remote I/O system, twice the voltage level means that any discontinuity along the line will cause twice the reflection of energy back to the source. This may prevent the system from functioning at all. At the very least it will cause errors. Discontinuities are caused by any deviation from the normal impedance level of 75 Ohms. The older taps (round in shape) have a typical impedance of 200 Ohms!) The Modicon revision "A" taps are nearly as high. A Quantum system will *not* function with these taps if placed close enough to the source of energy (head-end).
